**SUSQUEHANNA RIVER BASIN  
SPRING GROVE DAM  
P. H. GLATFELTER COMPANY**

**NDI NO. PA-01028  
DER NO. 67-004**

**YORK COUNTY, PENNSYLVANIA  
PHASE I INSPECTION REPORT  
NATIONAL DAM INSPECTION PROGRAM**

PHASE I REPORT  
NATIONAL DAM INSPECTION PROGRAM

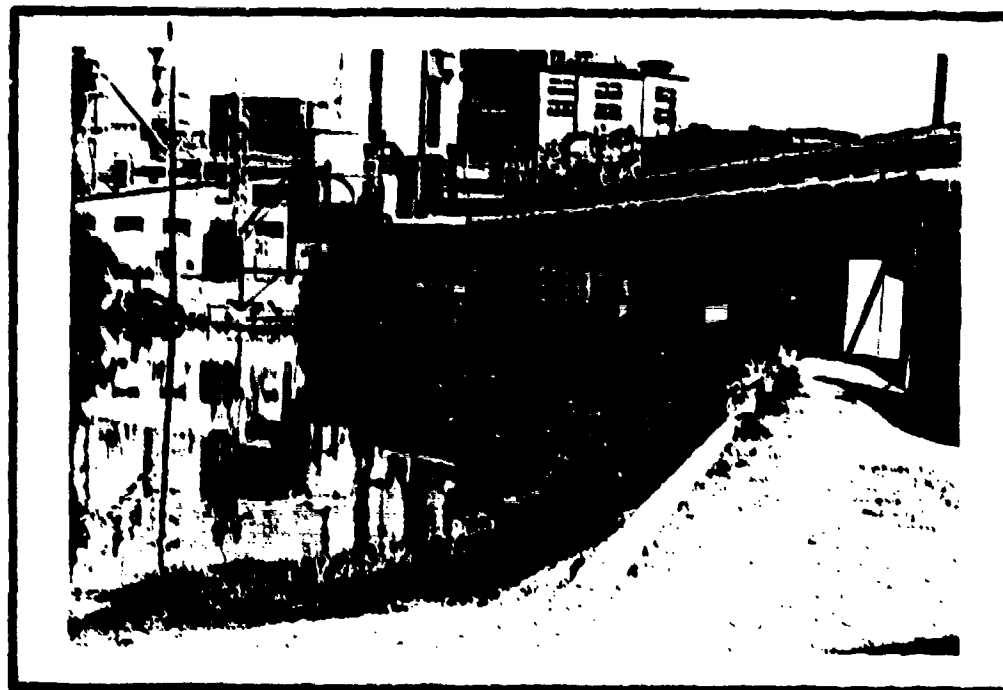
OVERVIEW LEFT EMBANKMENT - NO. 2  
NOTE: CONCRETE WALL AND PIPELINES

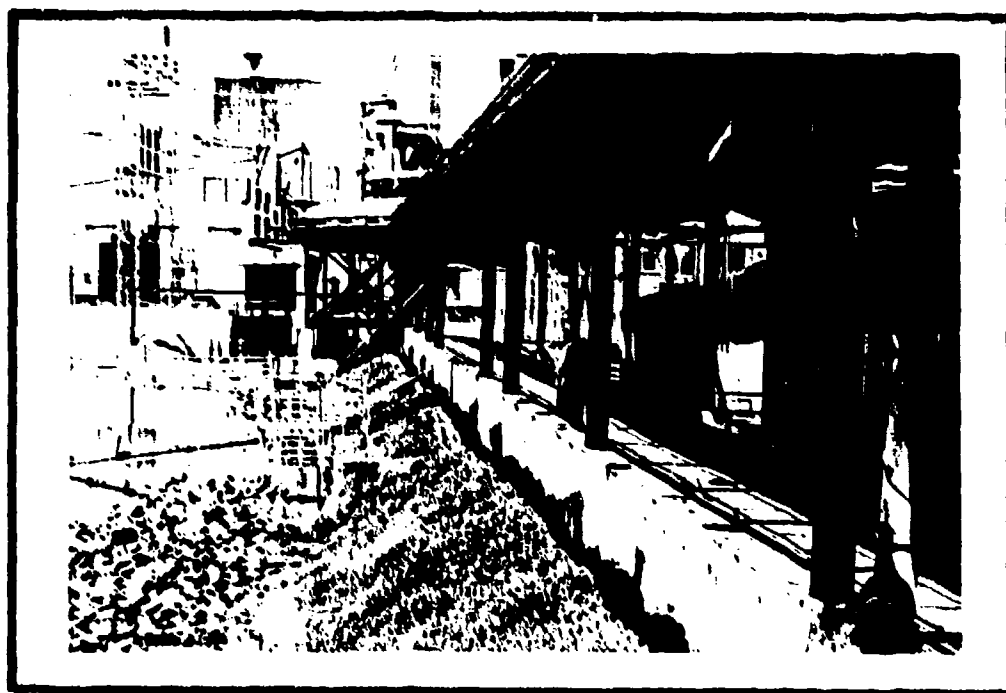
LEFT EMBANKMENT AND PARAPET WALL - NO. 3  
NOTE: BUILDING ON DOWNSTREAM SIDE

1. That the narrow crest between the parapet wall and the building be widened and the slope flattened.
2. That heavy rock for erosion protection be placed downstream of the spillway weir slab to prevent undermining of the slab.
3. That the flood control plan be expanded to include a downstream warning system.

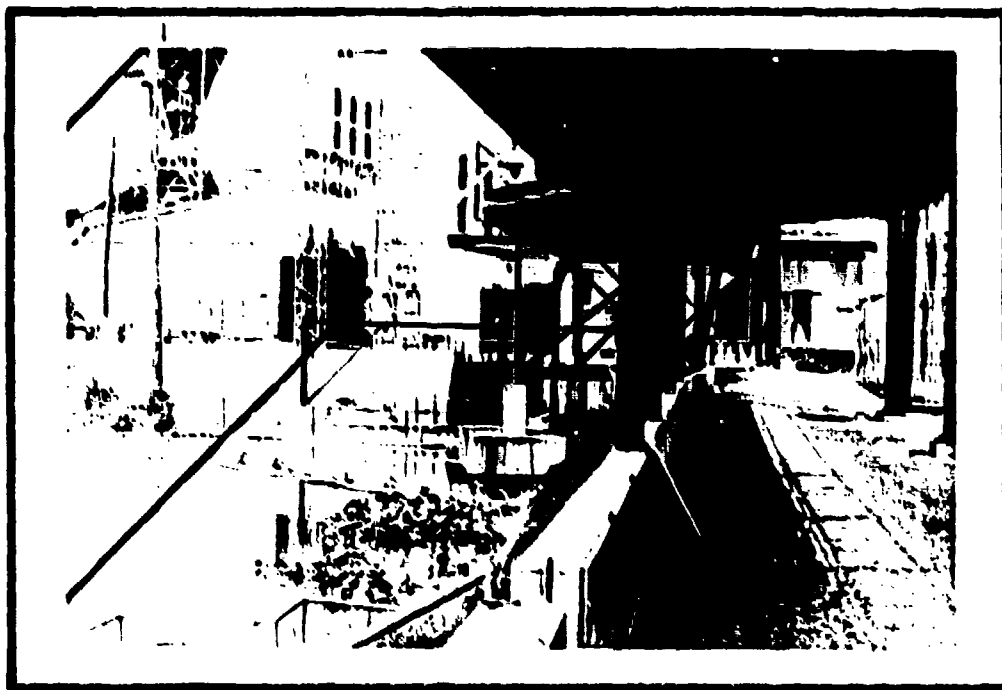
The left embankment abuts one of the industrial buildings and a railroad. Sandbags are stored adjacent to the railroad to close off this opening during flood flows. A concrete parapet wall begins at a distance of fourteen feet from the building. This wall increases the flood protection by approximately 2.4 feet above the previous earthfill elevation (Photographs No. 3, 4 and 7). The embankment has an actual width of about 14 feet and an upstream slope of 1.4H to 1V. Several sheds or buildings are located on the downstream slope of the embankment. One opening in the wall, located near its center, is used for access to industrial intake valves. This opening can be closed off with stoplogs (Photographs No. 4 and 6).

PARAPET WALL AND CLOSURE OPENING - NO. 4

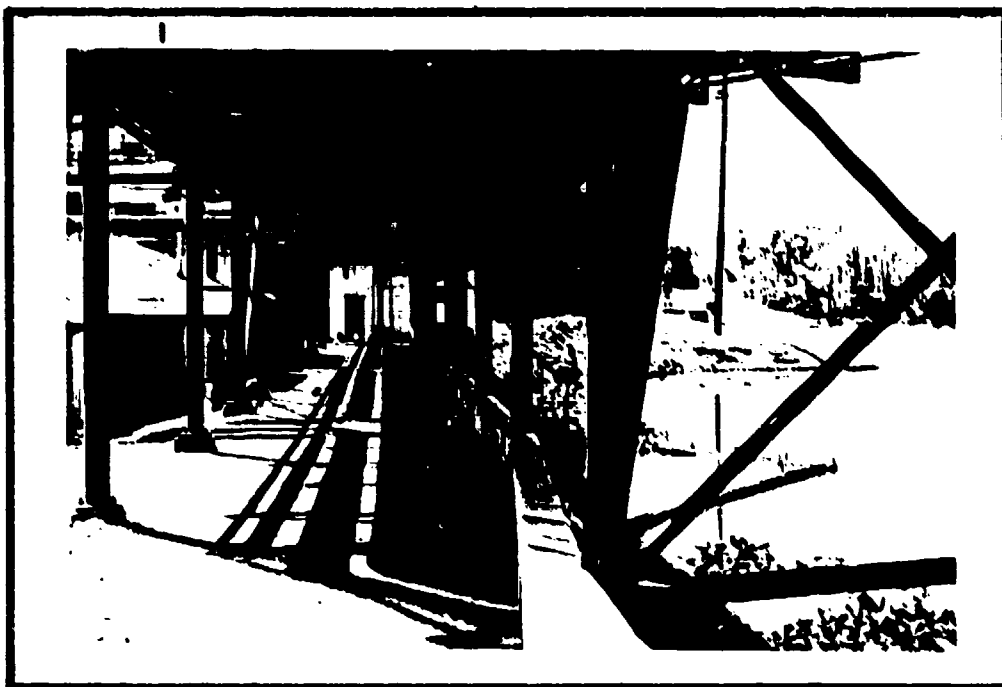
VIEW OF PARAPET WALL AND EMBANKMENT -- NO. 7  
NOTE: EMBANKMENT AND BUILDING IN BACKGROUND

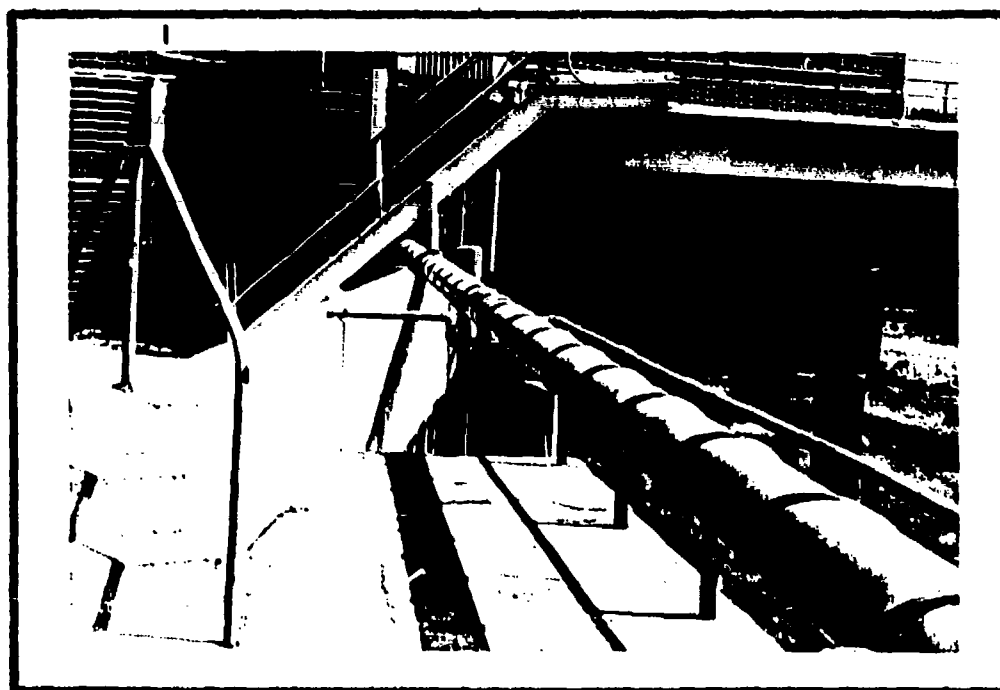
WALL TIE-IN AT BUILDING AND SPILLWAY - NO. 9

The spillway is located near the present right abutment of the embankment. The spillway abutment walls are massive concrete structures (Photographs No. 11 and 13). The left abutment has been tied into the new building with steel sheetpiling. The weir has a concrete surface and has deteriorated slightly (Photograph No. 14). At the downstream end of the concrete slab, there is a 2.0 to 2.5 foot deep pool. This pool is about 15 feet wide and has been caused by erosion during high discharges.

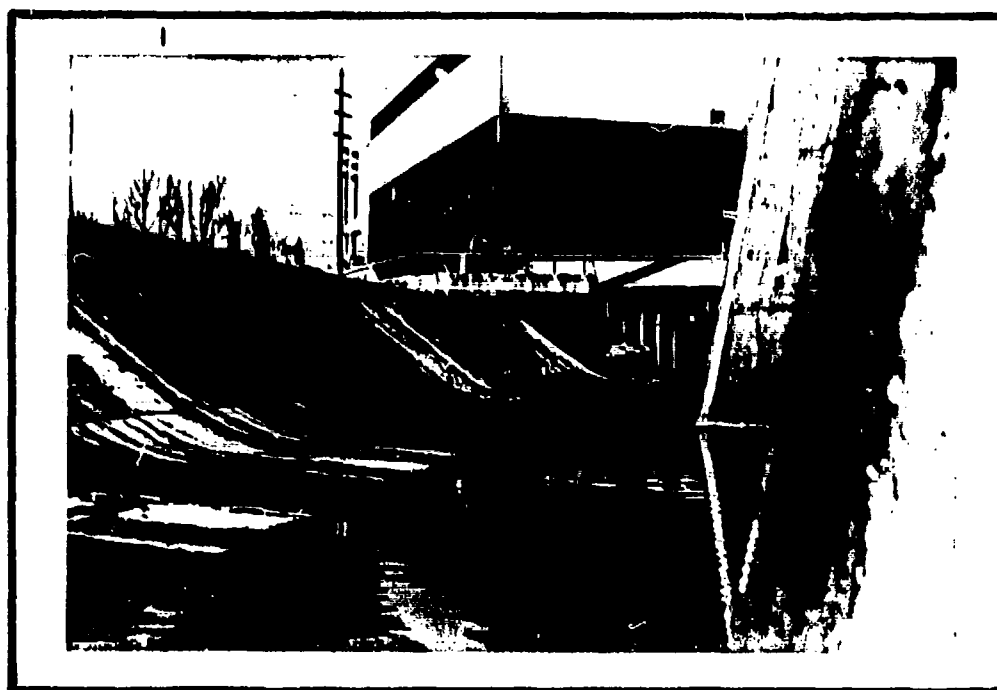
DOWNSTREAM FACE OF SPILLWAY - NO. 12

The concrete face on the downstream side of the spillway weir shows signs of deterioration. Riprap should be placed downstream of the spillway weir to prevent possible undermining of the slab.

2. That heavy rock for erosion protection be placed downstream of the spillway weir slab to prevent undermining of the slab.
3. That the flood control plan be expanded to include a downstream warning system.
4. That an operation and maintenance manual be prepared for guidance in the operation of the dam during normal and emergency conditions, and that a schedule be maintained for the annual inspection of the dam and its appurtenant structures.
